# **OPERATING EXPERIENCE WEEKLY SUMMARY**

**Office of Nuclear and Facility Safety**

**March 13 through March 19, 1998**

**Summary 98-11**

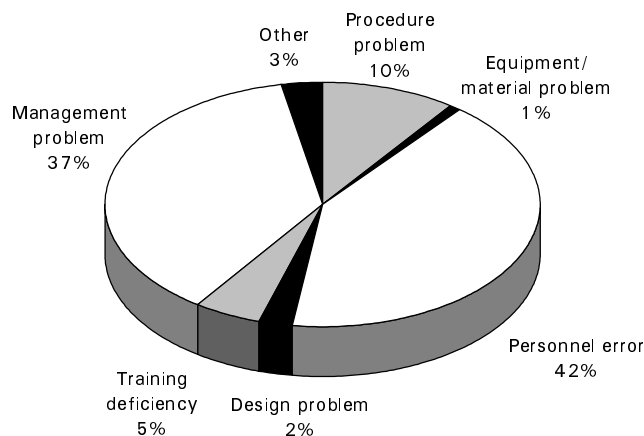
**Figure 1-1. Root Causes for Violation/Inadequate Procedures<sup>1</sup>**

OEAF engineers searched the ORPS database from 1990 to present for occurrences reported under Nature of Occurrence category 01F (Violation/Inadequate Procedures) and found 3,684 occurrences. Personnel error contributed to 42 percent of the root causes reported by facility managers for this category and procedures not used or used incorrectly accounted for 49 percent of the personnel errors. Figure 1-1 shows the distribution of root causes for violation/inadequate procedures.

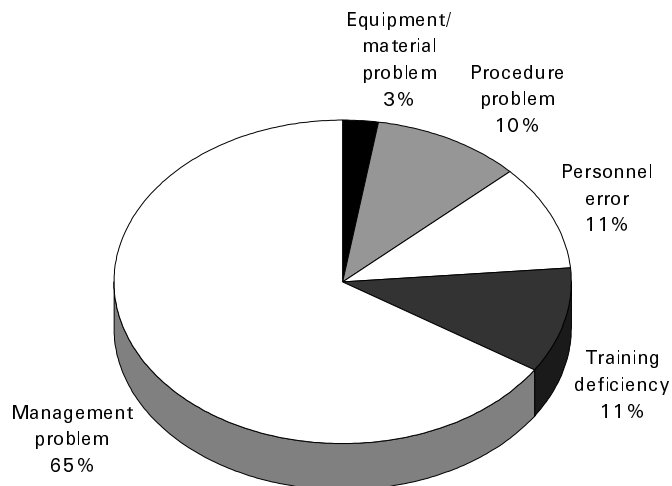
**Figure 3-1. Root Causes for Expired Qualifications Occurrences<sup>2</sup>**

OEAF engineers searched the ORPS database for events involving expired qualifications and found 41 reports. Figure 3-1 shows the distribution of root causes for these occurrences. A review of these occurrences shows that managers reported management problem as the root cause in 65 percent of the occurrences for which a root cause was identified. The root cause of 52 percent of these occurrences was identified as inadequate administrative control; 24 percent were attributed to policy not adequately defined, disseminated, or enforced.
